Wear characteristics of a combustion liner for power generation gas turbine

ABSTRACT – The occurrence of wear damage was observed on a combustion liner of a power generation gas turbine. The combustion liner is made of nickel based superalloy (Hastelloy X). The worn surface generally occurred at mating surfaces of the combustion liner. The purpose of this study is to determine the types of wear at three different mating surfaces (connected to a SS304 stainless steel, Nimonic C263 and carbon steel) after being exposed to 8,000 of running hours at high temperature and vibration. The affected areas of the mating surfaces were analyzed and the wear mechanism was discussed.

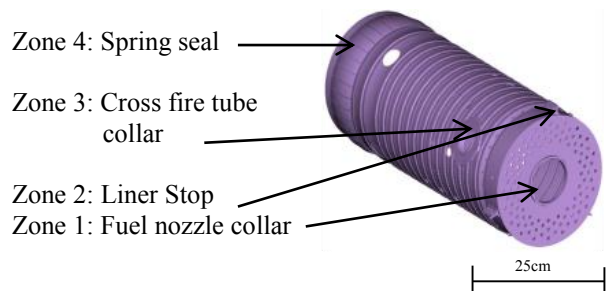
In this work, the combustion liner was taken from a 97MW gas turbine. The process took place due to a reaction between fuel and gasses inside the combustion liner. The involved temperature was 1100°C. Figure 1 shows the 4 mating surfaces on a combustion liner. These 4 surfaces were selected based on their wear severity and consistency for the refurbishment processes [2].

Figure 1 Selected components of a combustor liner.
