Problems of rolling bearing life in small turbojet engines

ABSTRACT – This paper presents investigations results of several worn rolling hybrid bearings with ceramic Si₃N₄ balls and steel raceways – 608 type. Bearings were acquired from small turbojet engines, used in aircraft models, after its have reached the service life. Authors used scanning electron microscopy, light optical microscopy and non-contact profilometry techniques for bearing elements examination.

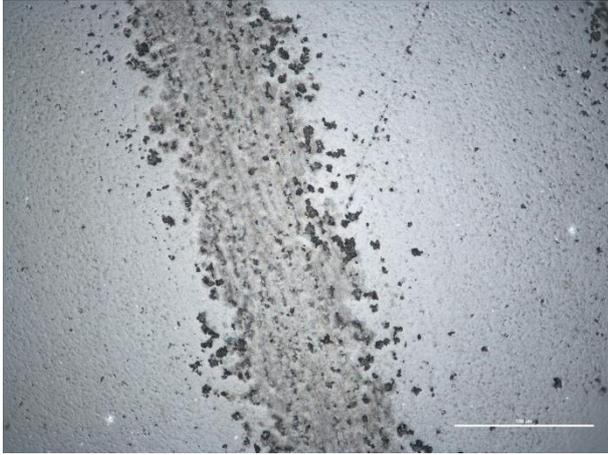
Figure 3 Worn surface of worn Si_3N_4 ball – bright field, 100 μm scale (10x20).

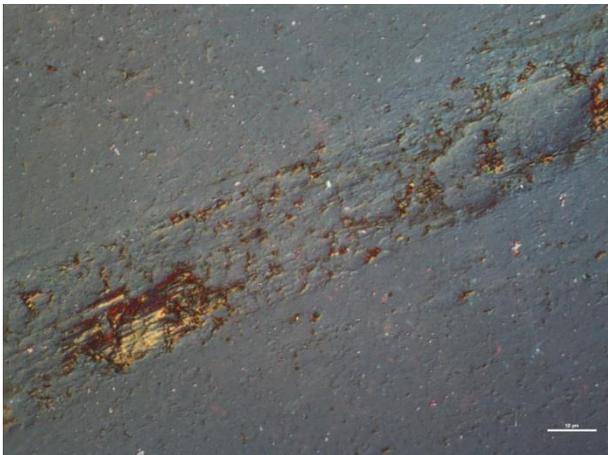
Figure 4 Worn surface of worn Si_3N_4 ball – bright field DIC, 10 μm scale (10x100).
